CT-285

INVENTORY FORM FOR STATE HISTORIC SITES SURVEY

F. Helb Barn

Calvert Cliffs State Park Barn

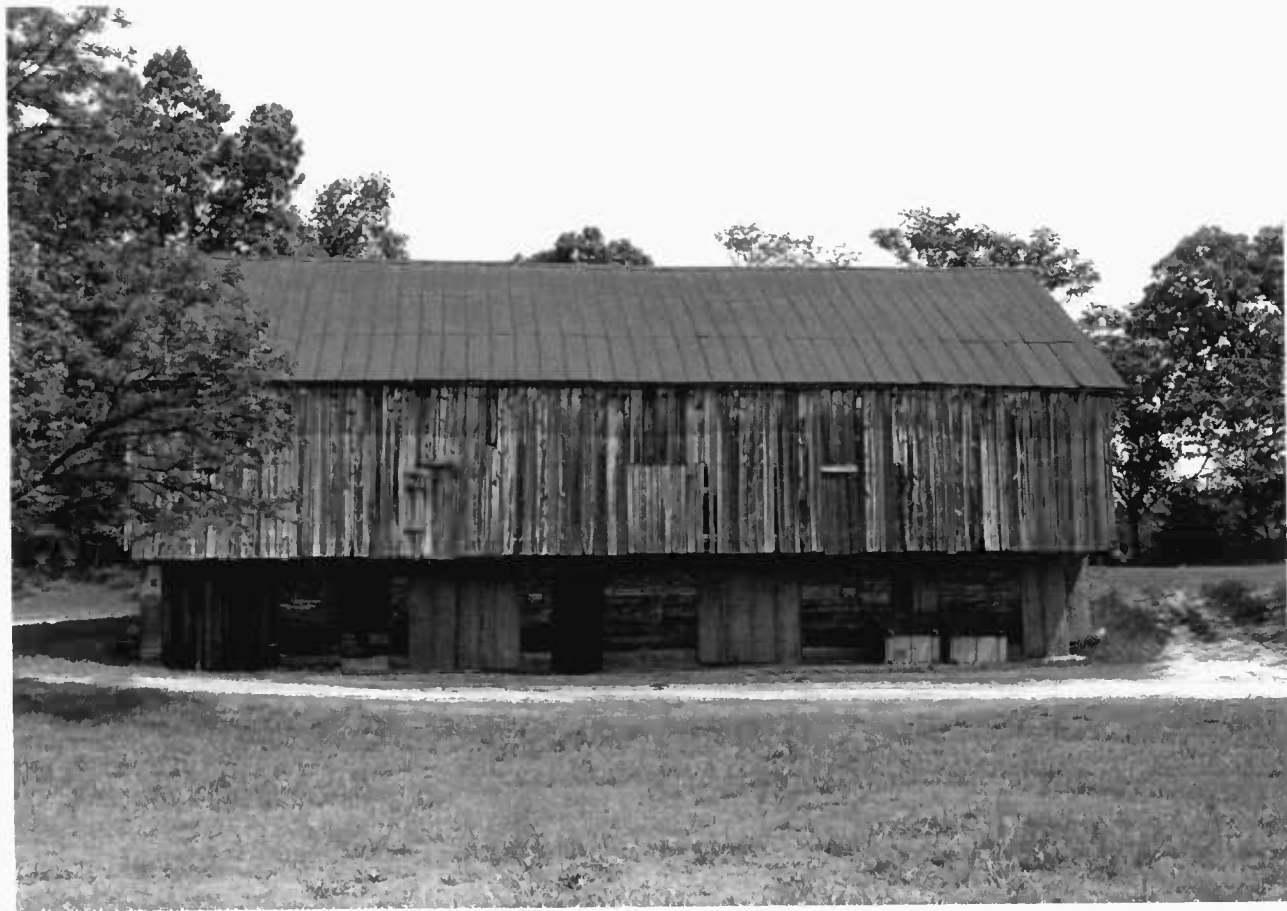
South elevation

The southern elevation which constitutes the principal entrance facade is punctuated by two major door openings, large sliding doors several feet wide and consisting of horizontal wooden planks mounted on rollers in metal tracks of galvanized aluminum. Some of the boards on the northwest portal are pried loose on one side, admitting access even though the door no longer operates properly. Below the planking is a brick foundation which is six or seven courses deep on this facade. From the northwest corner this foundation then increases to a depth of fifteen courses at the southwest corner of the building.

The entire wooden superstructure overhangs the brick basement level by four to five feet on the southern facade. This wide overhang provides ample shelter for equipment (or animals) and provides protected access for the three principal doorways which open into storage areas, formerly stalls. These openings are presently boarded shut with vertical planking which contrasts with the horizontal sheathing of the remainder of the facade. At the southwest corner, about 6 feet above ground level, is a dated brick (about twice as large as its neighboring bricks and inscribed with the legend "Built by F. Helb 1881"). The sill supporting the overhang is pegged.

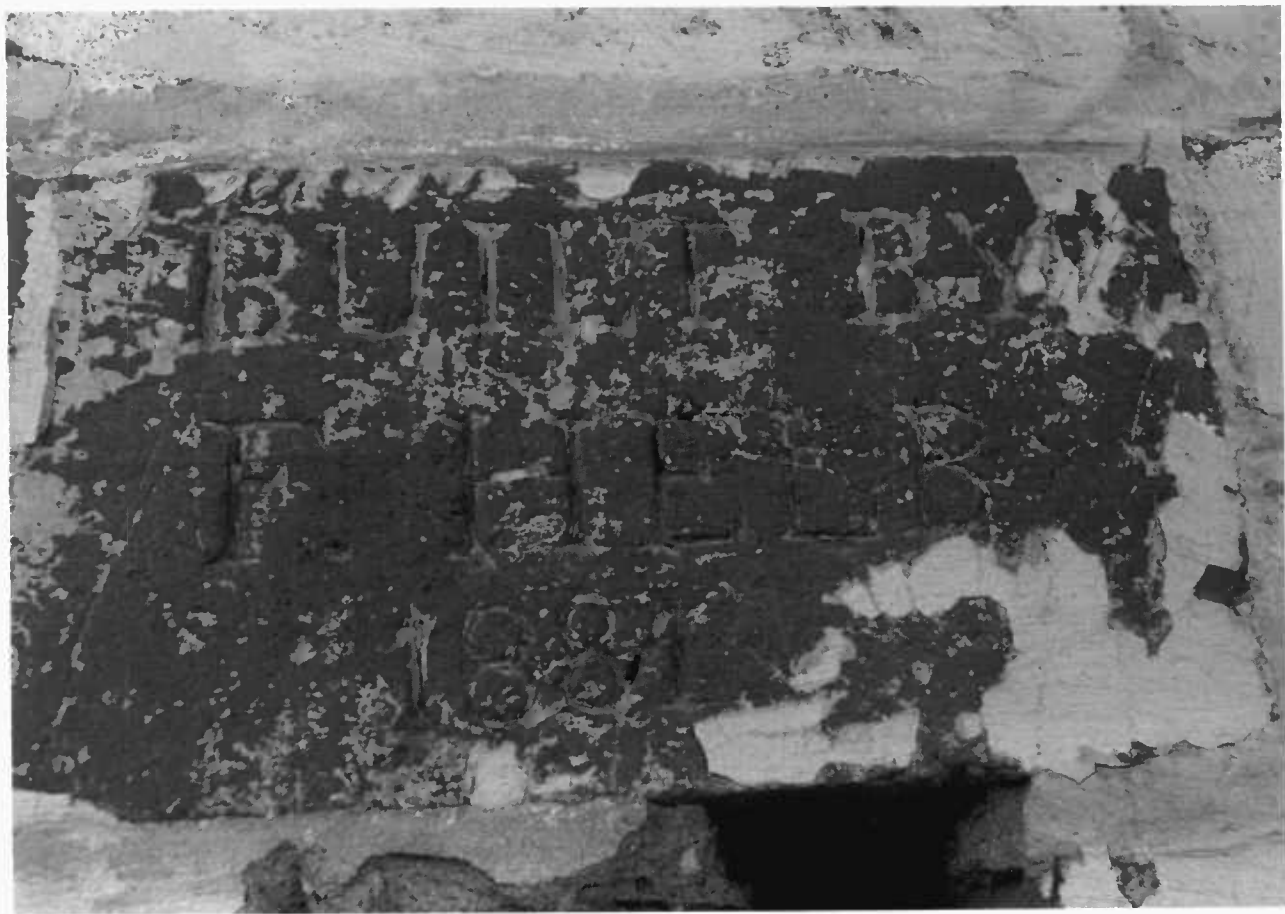
Dated brick, southwest corner
April 1979 E. Coxe

This building demonstrated notable interpretation of the type in brick and frame. It features an unusual dated brick in the southwest corner of the structure about six feet above ground level bearing the legend: "BUILT BY F. HELB, 1881".

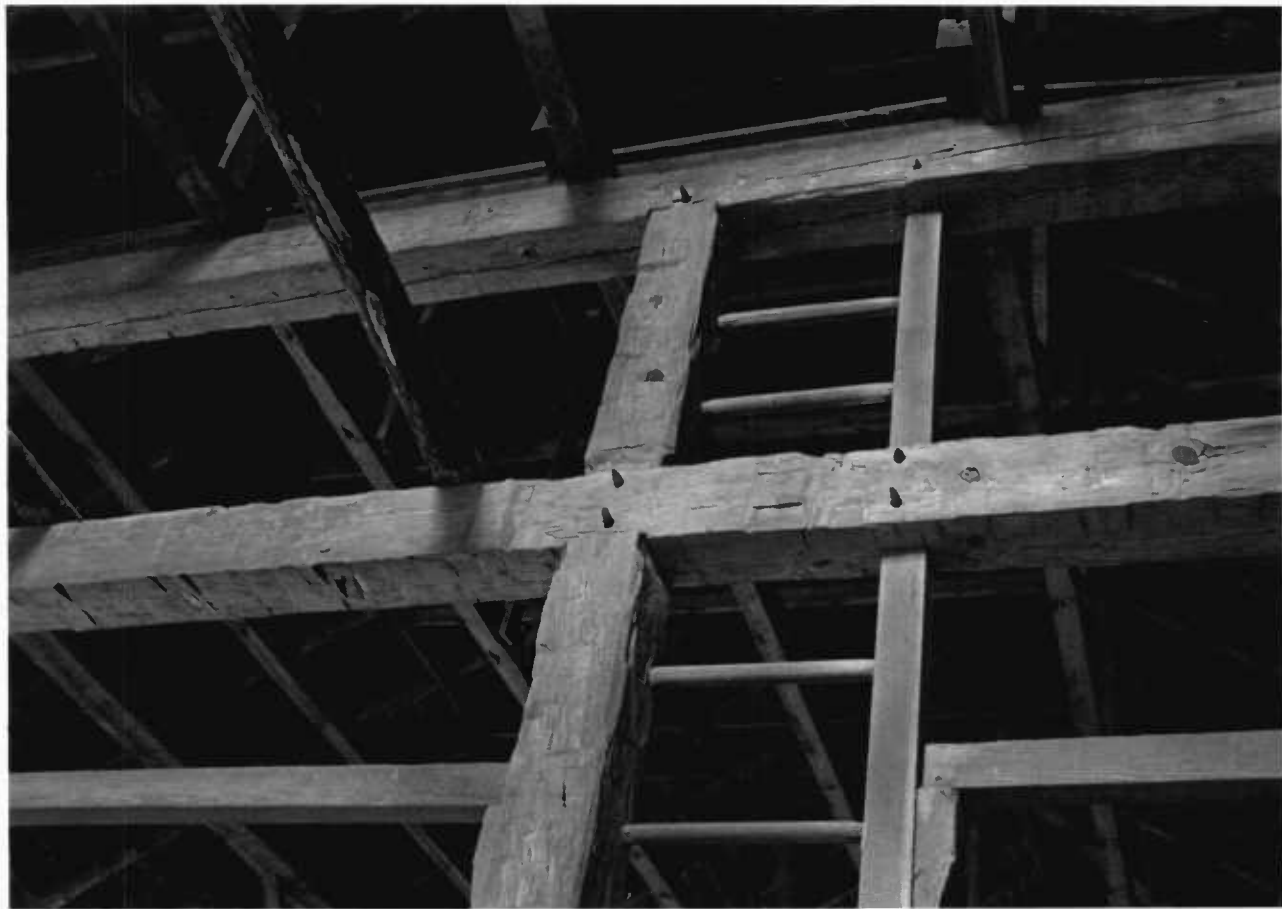
The interior of the barn is characterized by a six-bay system. The two principal bays are the center two (see diagram), of which the vertical supports are double mortised into the lower tie beam and pegged on both sides. The four principal vertical supports are on central posts with systems of cross bracing which stop at the level of the top of the topmost tie beam. Additional supporting purlins are necessary for the unusual length of the barn. Bracing is mortised and pegged throughout the structure and replacement pieces have been inserted, mostly in the area of new floor boards. These planks are about ten inches wide, and for the most part are original.

Interior, middle bay showing
cross beams and pegging
April 1979 E. Coxe
